MISCELLANEOUS PAPER GL-84-7

IMPROVED SURFACING MATERIALS FOR TRACKED VEHICULAR TRAFFIC

Geotechnical Laboratory

June 1984

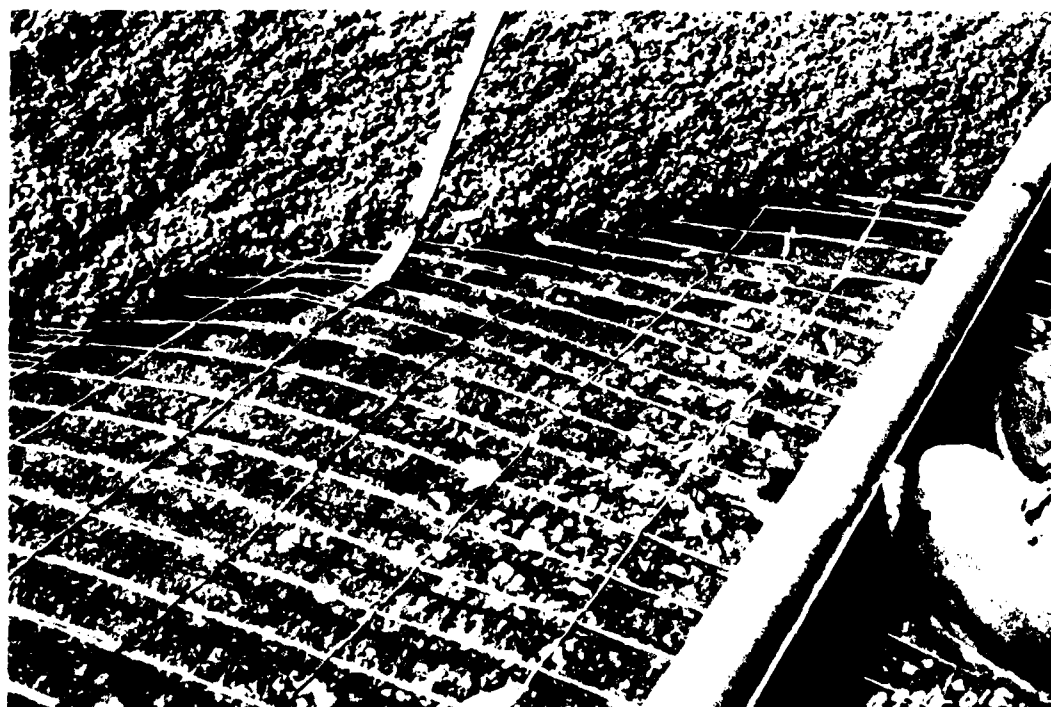
Photo 4. Placing concrete in item 4

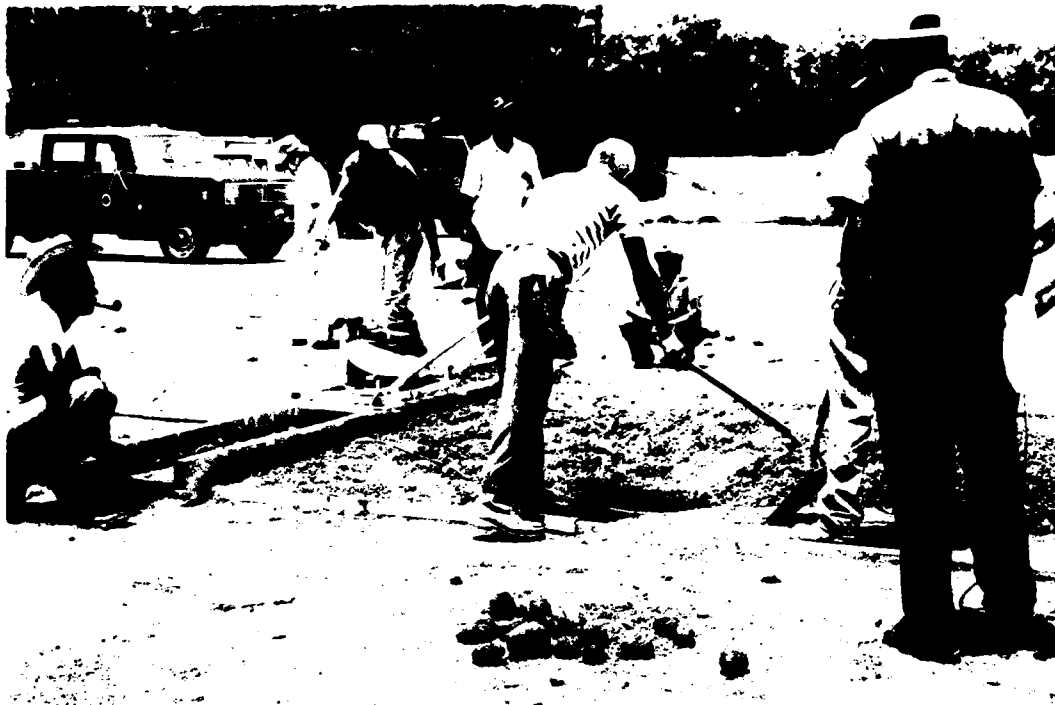
Photo 5. Placing fibrous concrete in item 3

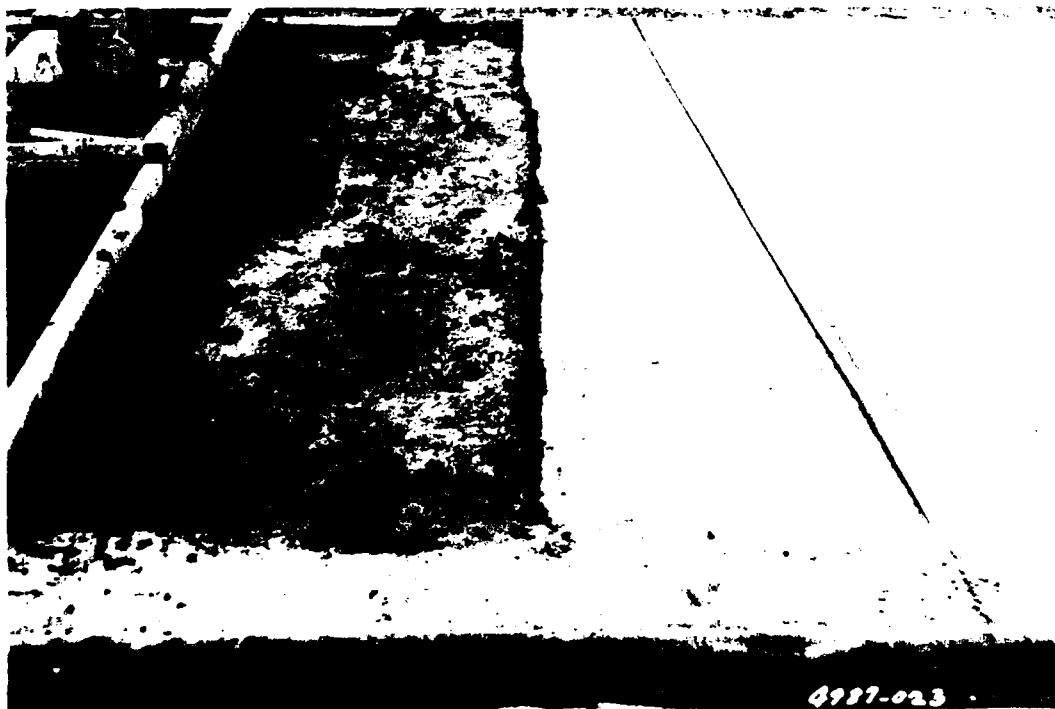
Photo 6. Construction joint in item 10

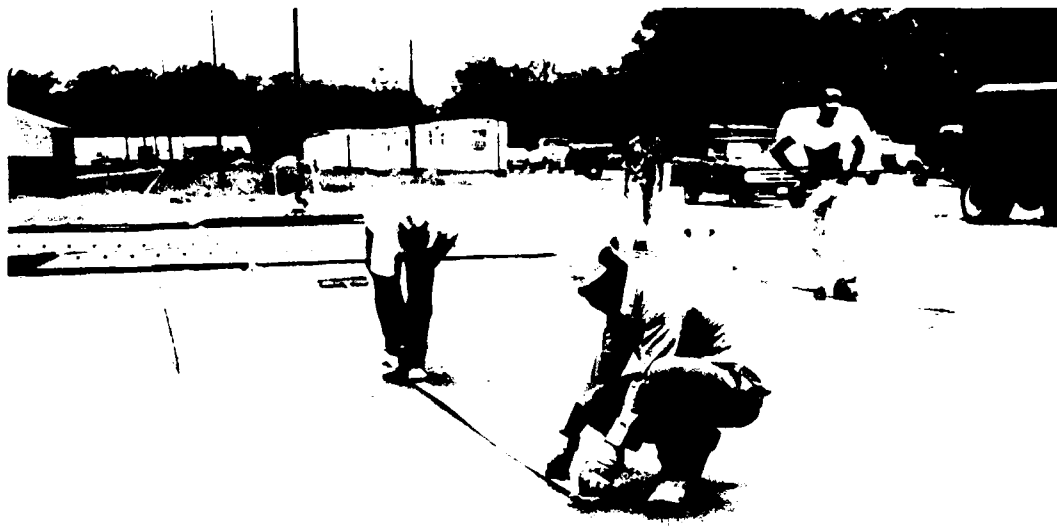
Photo 7. Forming weakened plane joints in items 1-10

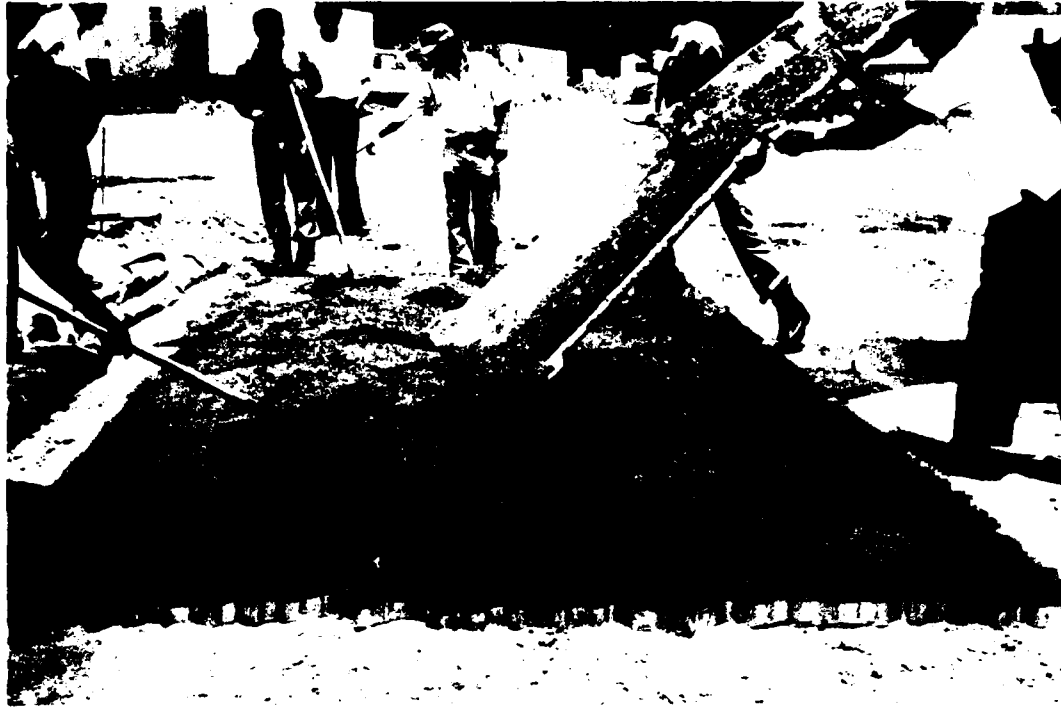
Photo 9. Placing concrete in grids by chute

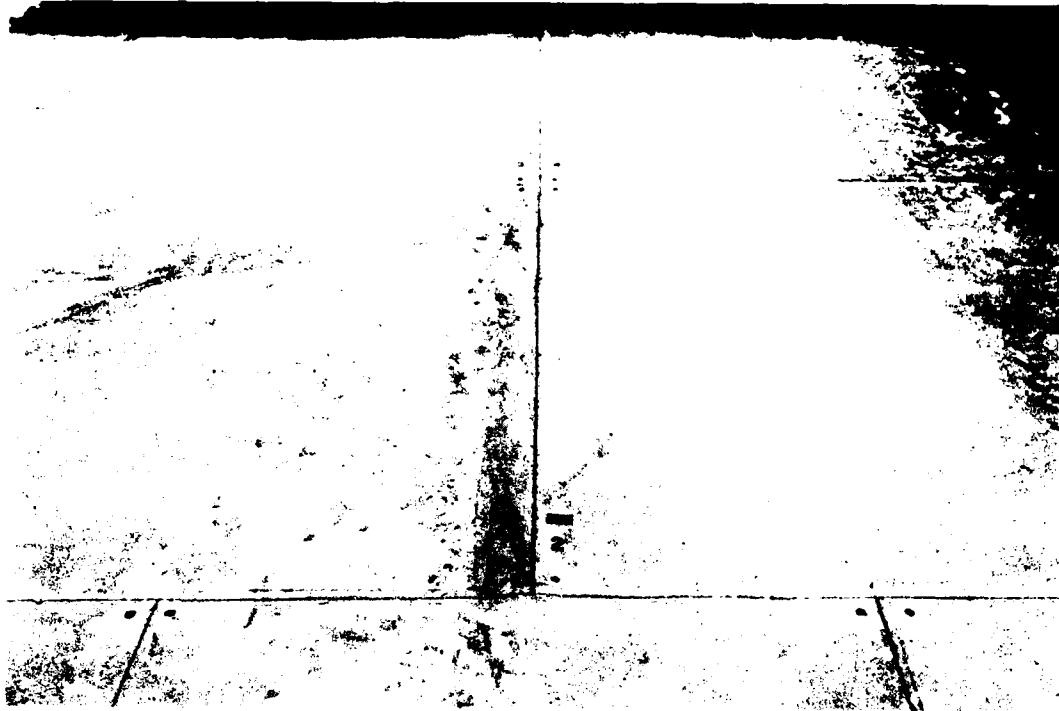
Photo 21. Item 10 before traffic

- j. Item 10 also consisted of 4 in. of plain PCC (Photo 21).
- k. Item 11 was composed of aluminum grids (Photo 8) that were 2 in. deep and filled with plain PCC as shown in Photo 22. The small holes were caused by a reaction of the cement in the concrete with the aluminum grids prior to traffic.

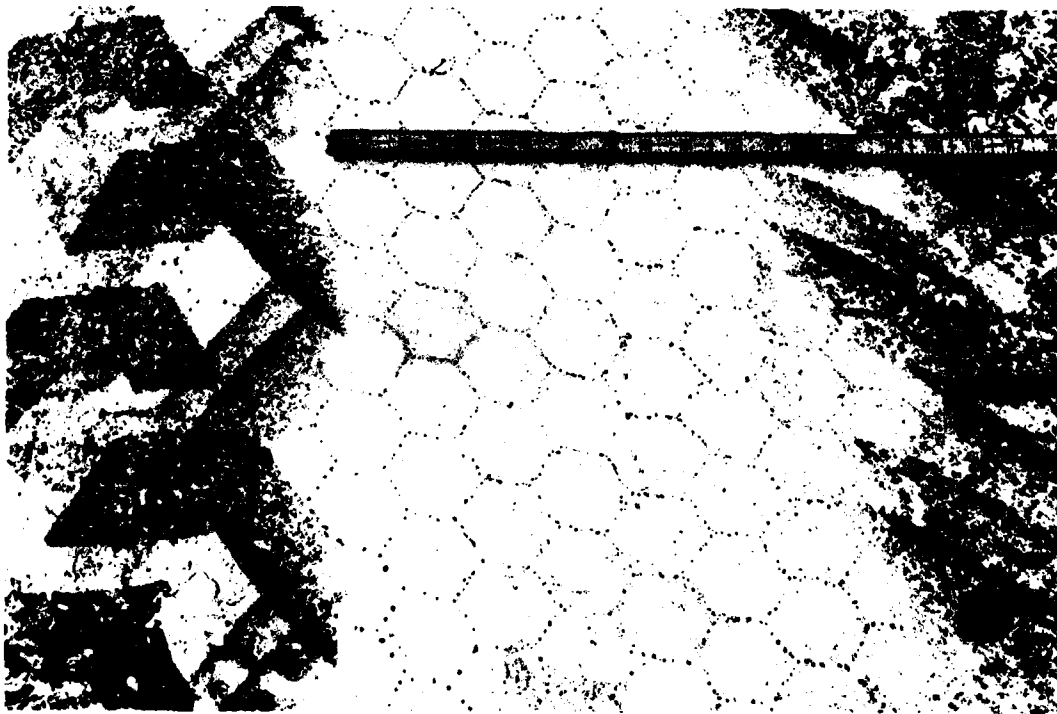
Photo 22. A closeup view of item 11

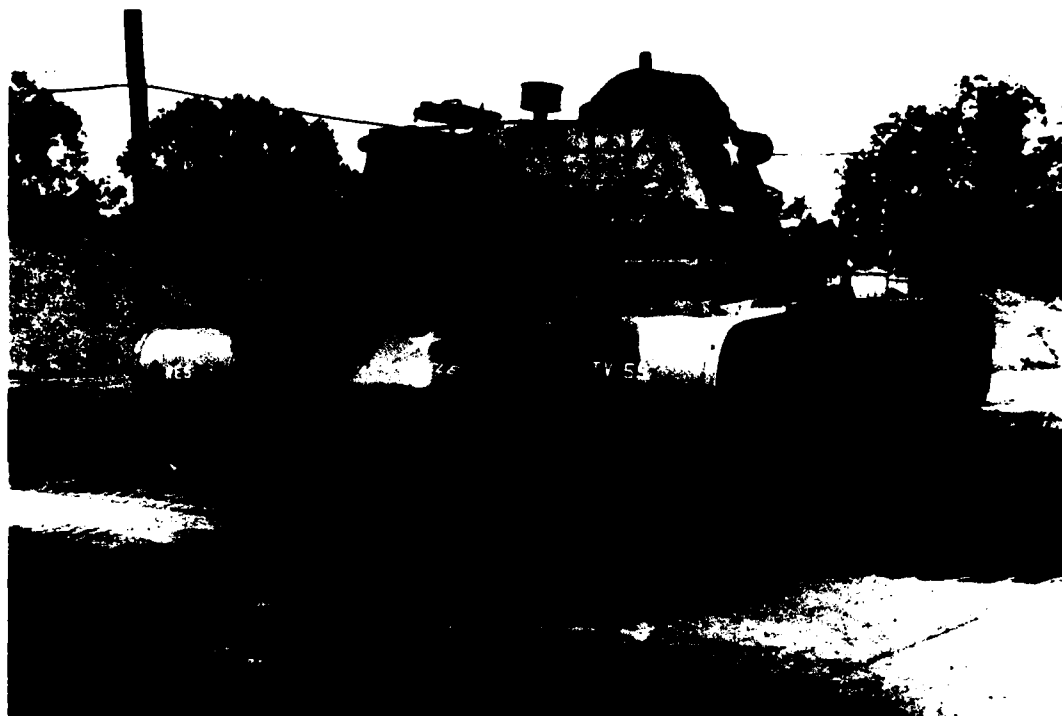
Photo 23. View of M-48 tank loaded with blocks
to simulate combat weight

9. Traffic consisting of 5,000 passes and 1,000 turns was applied to each item with an M-48 tank that was loaded with extra weights to a total load of 114,000 lb which is the approximate combat weight of an M-1 Abrams tank (Photo 23). The test section consisted of north and south traffic lanes. The north lane consisted of six test items and the south lane had five test items. Traffic was applied so that one pass was applied to the north lane and then one pass to the south lane. During each pass on a traffic lane, a locked track turn of 90 deg was accomplished on one of the test items so that when five passes of the tracked vehicle were completed, each item had been subjected to a locked track turn. These turns consisted of locking one track, turning 90 deg, and then returning to the original position in the reverse order.

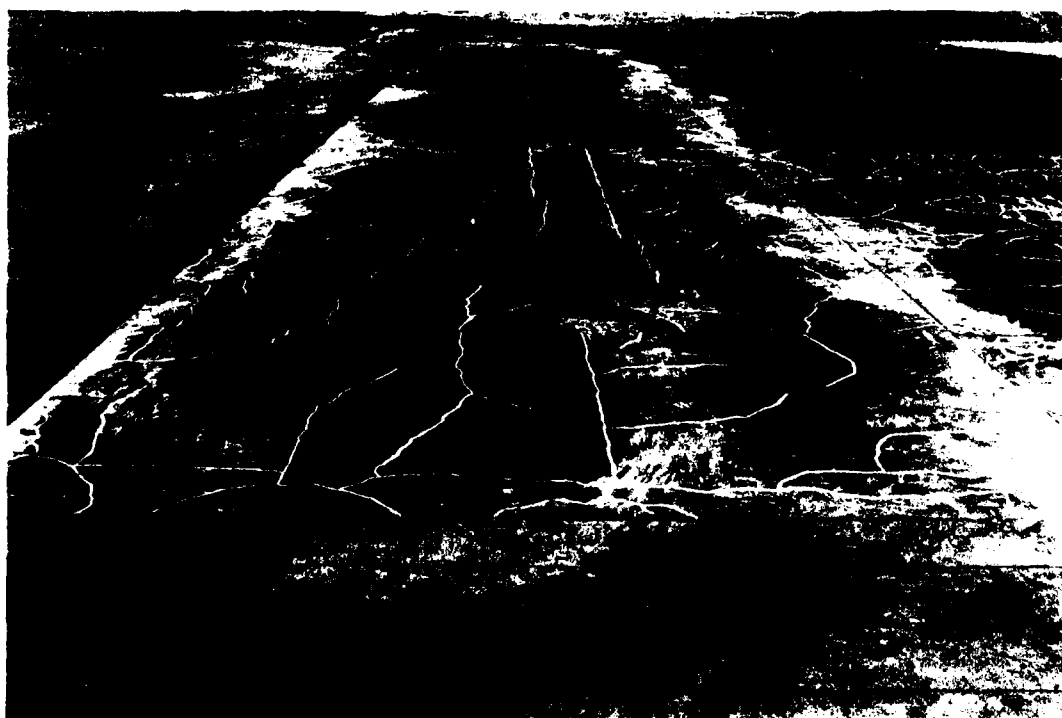
Photo 24. Item 1 after 2500 passes and
500 turning movements

- a. Item 1. Cracks occurred in two slabs prior to the start of traffic. During traffic, cracking occurred rapidly and the slabs had broken into an average of 11.5 pieces per slab at 1250 passes and 250 turns of the tank. There was very little additional cracking at 2500 passes and 500 turns (Photo 24), but the average number of pieces per slab increased to 28 after 5000 passes and 1000 turns (Photo 35).

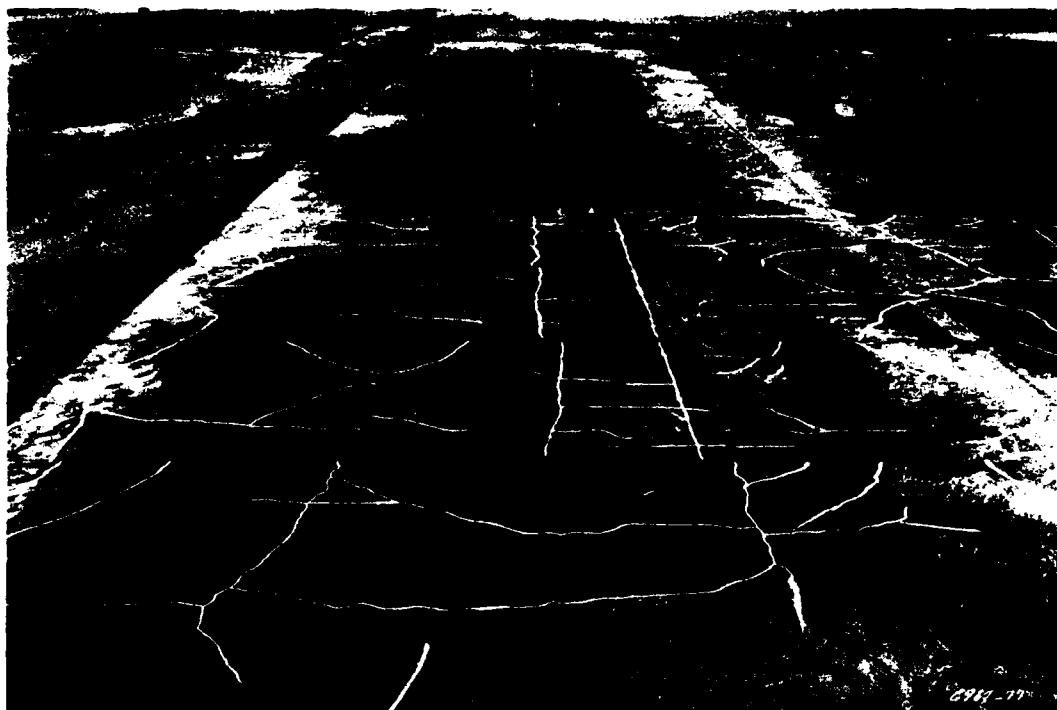
Photo 25. Item 2 after 2500 passes and
500 turning movements

- b. Item 2. Two slabs of item 2 had cracked prior to traffic. Cracking increased in the slabs with traffic (Photo 25), and the average number of pieces per slab was 11.4 after 5000 passes and 1000 turns (Photo 36).

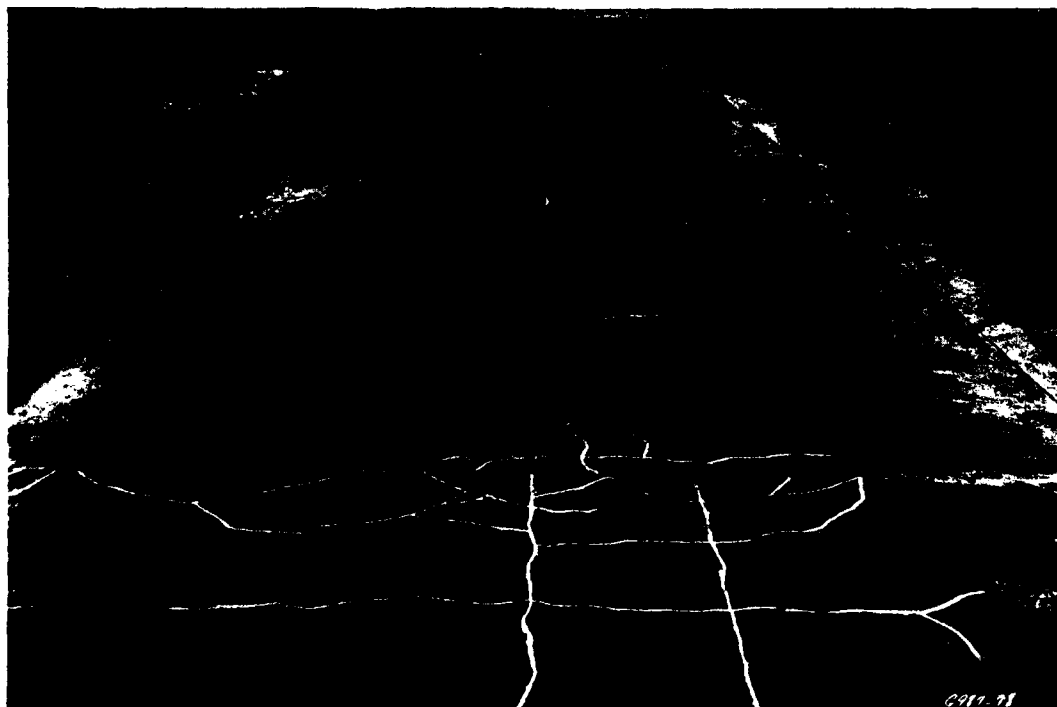
Photo 26. Item 3 after 2500 passes and
500 turning movements

- c. Item 3. Item 3 performed well under the applied traffic. There was no cracking prior to traffic, but the item had broken into 3.5 pieces per slab when traffic was completed. The slabs had an average of 3.5 pieces per slab at 2500 passes and 500 turns (Photo 26) and showed no increase in cracking after 5000 passes and 1000 turns (Photo 37).

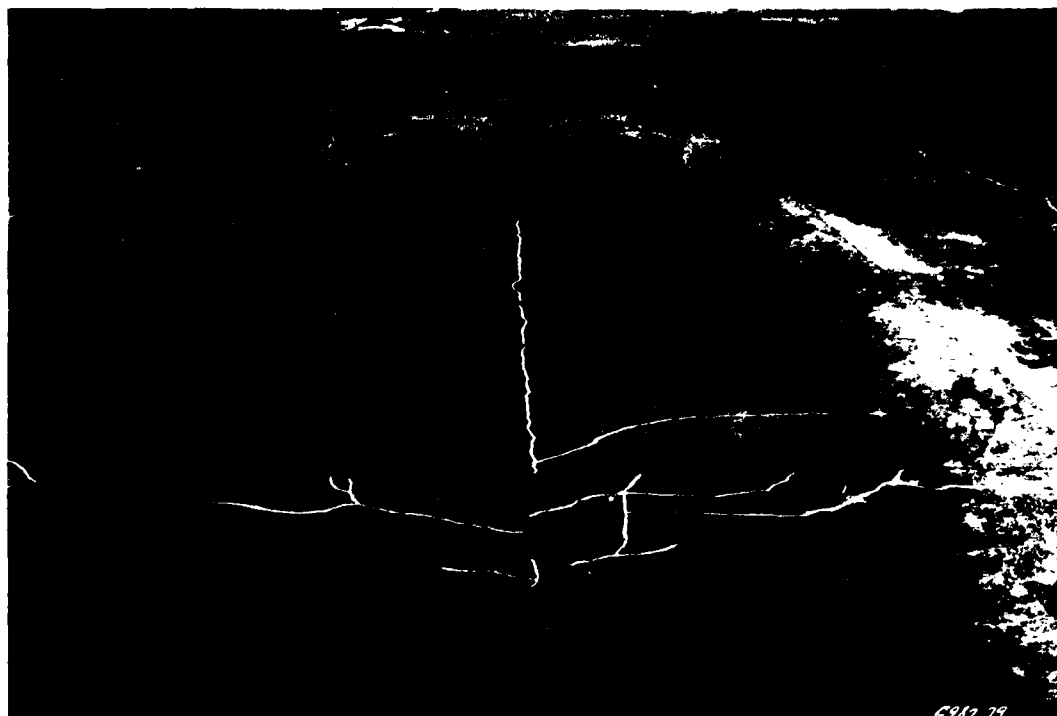
Photo 27. Item 4 after 2500 passes and
500 turning movements

- d. Item 4. The reinforced concrete in item 4 performed well. One slab had cracked prior to traffic. The other slabs contained a minimum number of cracks after 2,500 passes and 500 turns but soon broke into an average of 1.8 pieces per slab after 5000 passes and 1000 turns (Photo 38). The item therefore did not reach initial failure.

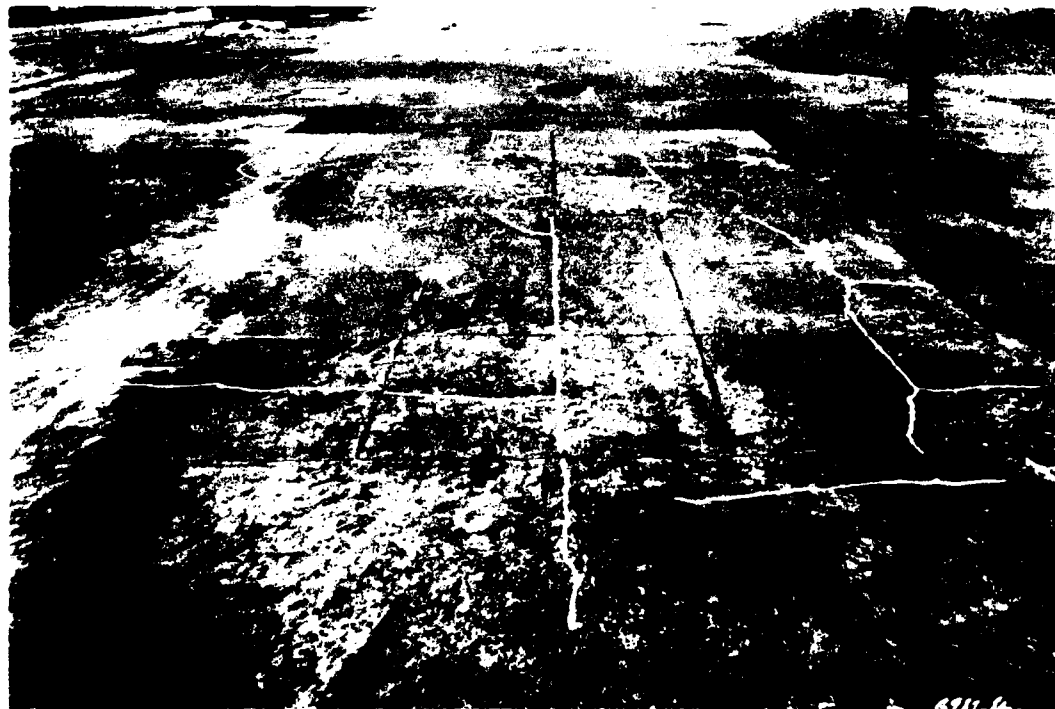
Photo 32. Item 9 after 2500 passes and
500 turning movements

- i. Item 9. The center slabs of this test item developed sympathy cracks for the full length of the test item prior to traffic. As the traffic increased from 2500 passes and 500 turns to 5000 passes and 1000 turns, two slabs showed no cracking although the average number of pieces per slab increased from 2.2 to 3.6 which was slightly past initial failure (Photos 32 and 43).

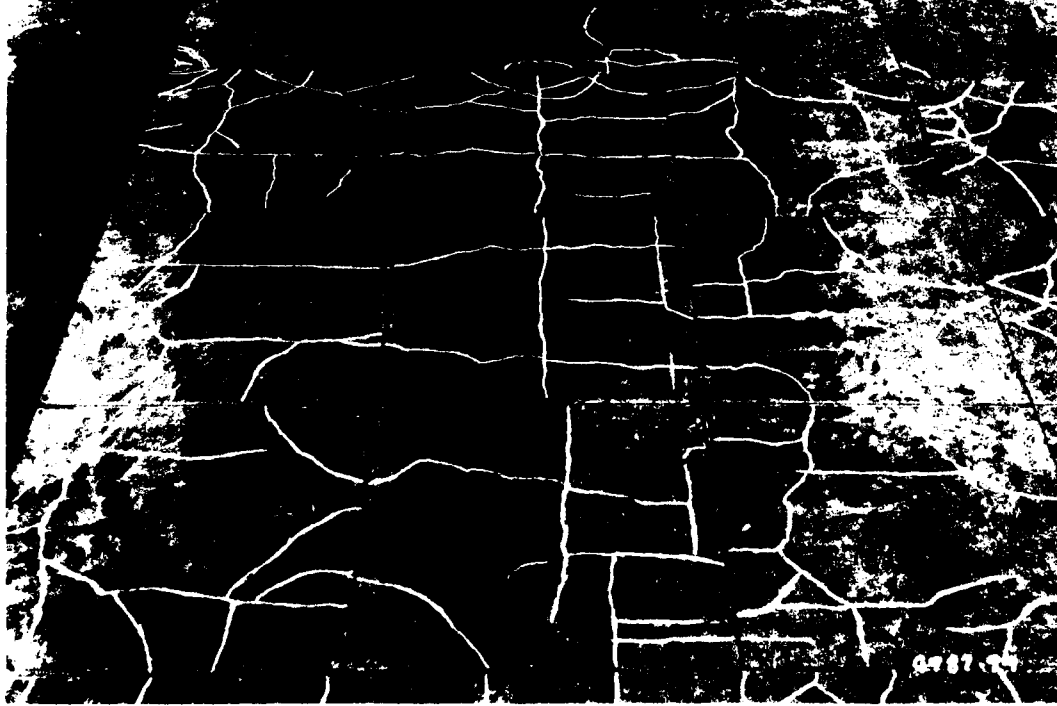
Photo 36. Item 2 after traffic tests were completed

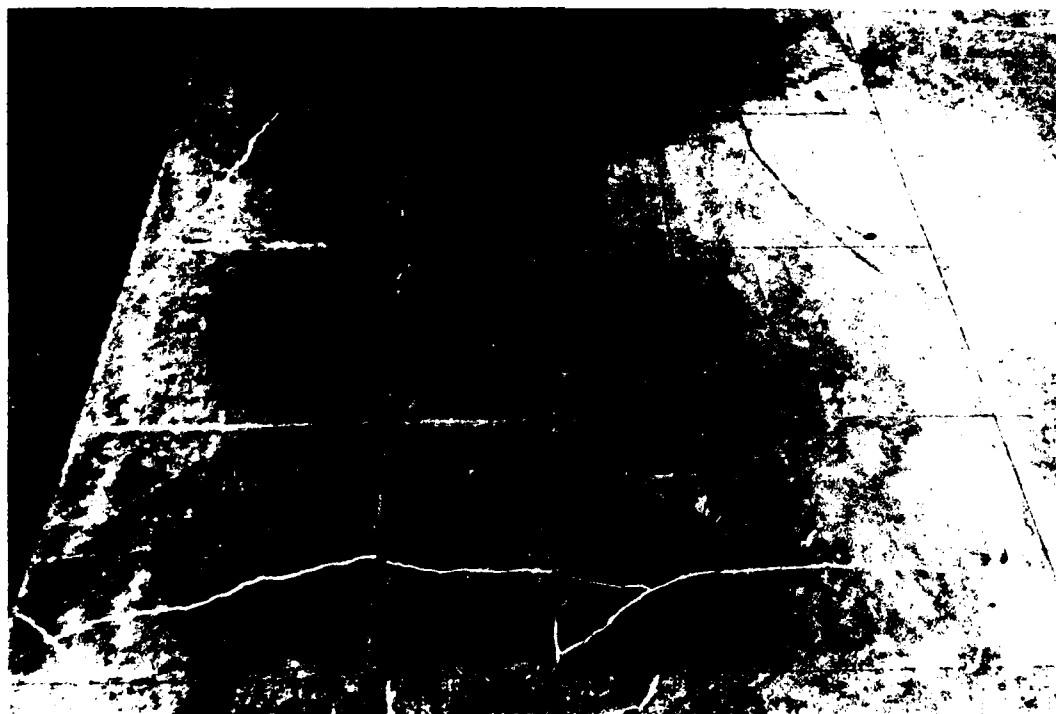
Photo 38. Item 4 after traffic tests were completed
